PHASE I INSPECTION REPORT  
NATIONAL DAM SAFETY PROGRAM

YELLOW WATER MAIN DAM (MT 12)  
AND  
YELLOW WATER DIKE (MT 3205)  
WINNETT, MONTANA  
PETROLEUM COUNTY

PREPARED BY:  
HKM ASSOCIATES  
BILLINGS, MONTANA

SEPTEMBER 1980

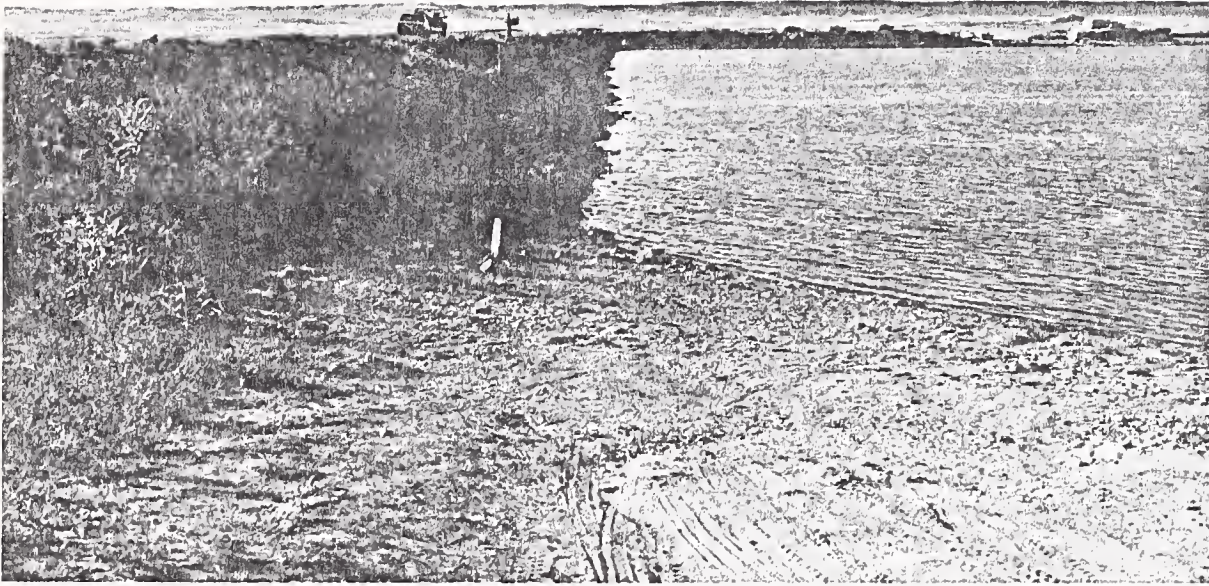
Photo No. 1 - Upstream face of Dam  
 Outlet works control tower and operator shown in photo center. Standing at the left abutment looking south. The 3 autos lined-up in the background are on the crest of the main dam near the spillway entrance.

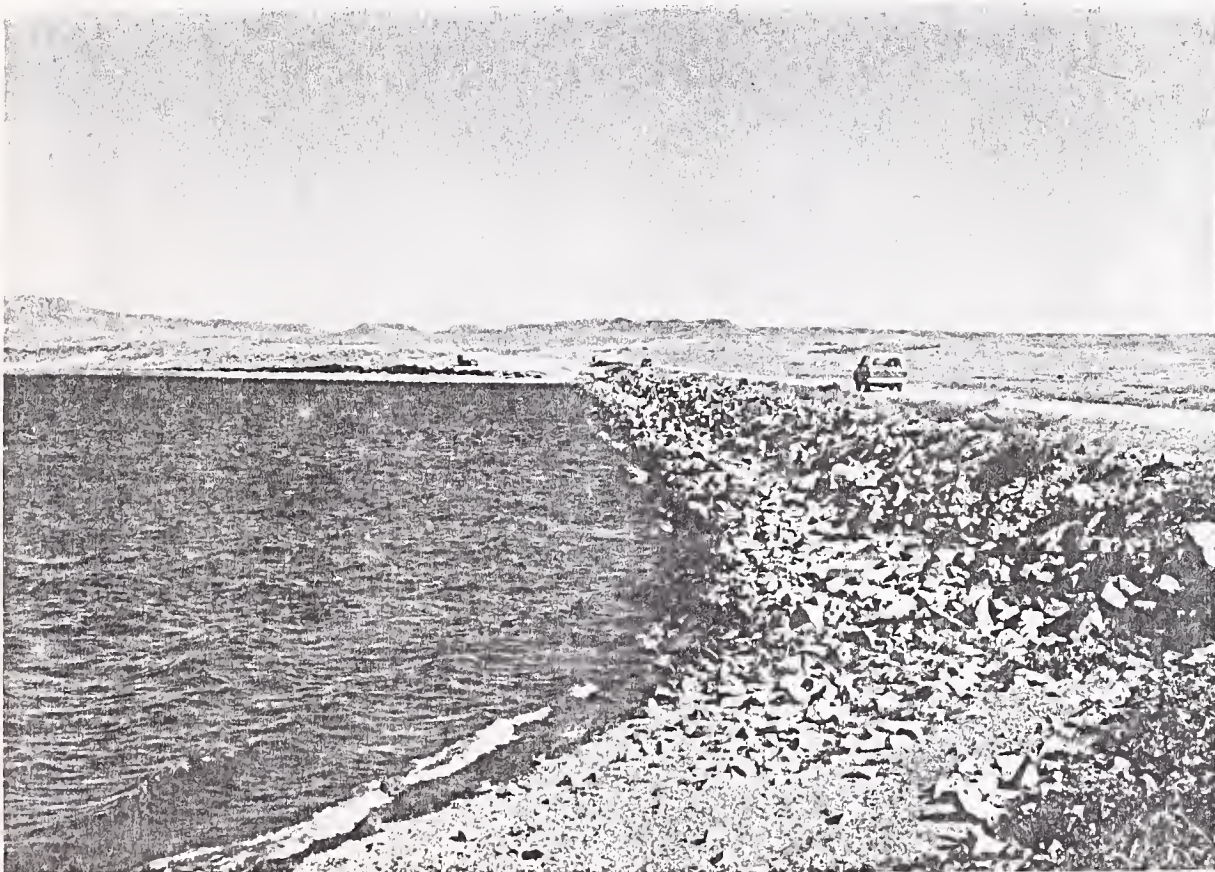
Photo No. 2 - Upstream Face of Dam  
 Looking north toward the left abutment. Notice the riprap thins in the foreground where the natural soil is exposed. This photo shows the main embankment.

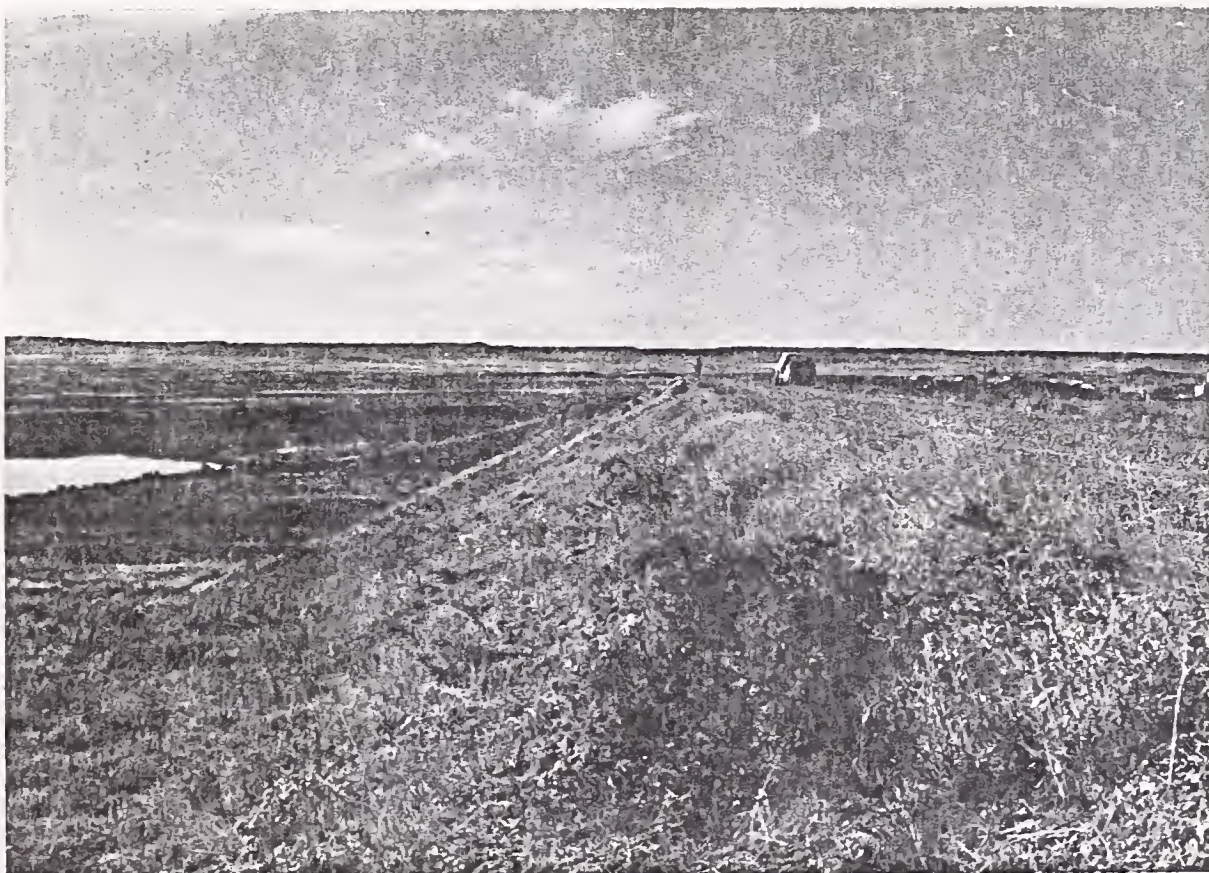
Photo No. 4 - Downstream Face of Dam

Looking south along the main embankment. There is a berm located about 2/3 of the way down the slope. Notice the vegetative cover. Also note water ponding downstream of the dam embankment.

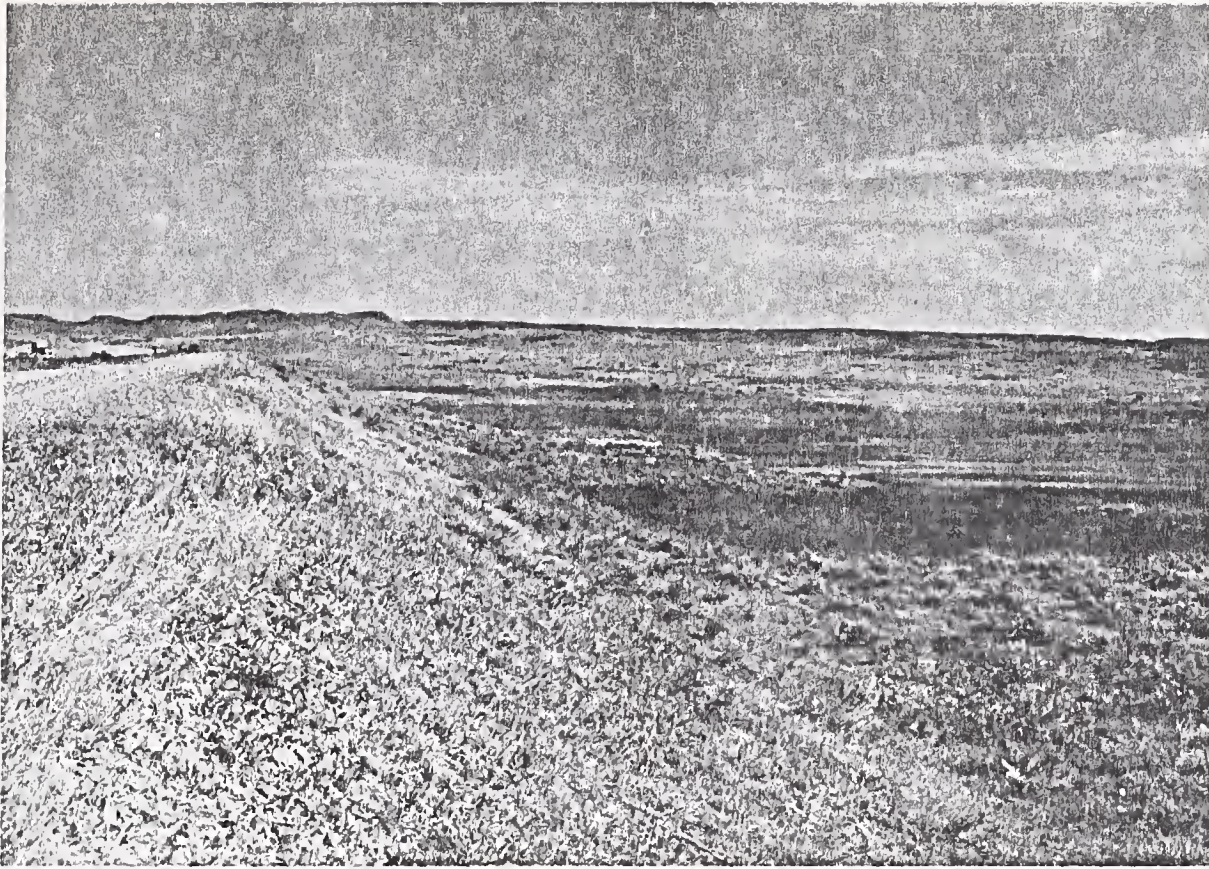
Photo No. 5 - Downstream Face of Dam

Looking north toward the left abutment. There is a moderate vegetative cover of natural grass, weeds, and sagebrush on the downstream slope. Source for ponding water is seepage and water from the low-level outlet return channel.

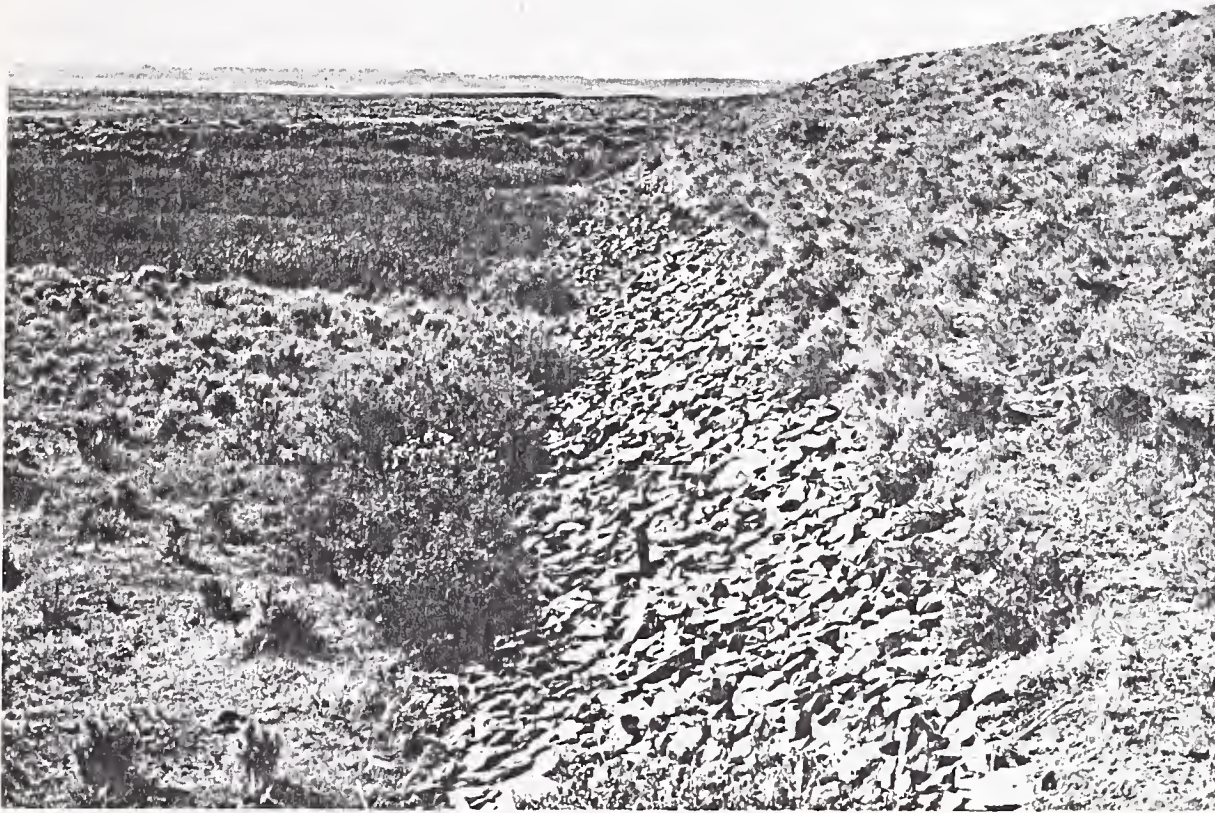
Photo No. 7 - Rock Toe of Embankment

There is a rock toe at the base of the main embankment. This material is very coarse and erosion resistant. Water is exiting from this material at several locations. See also Photo No. 28.

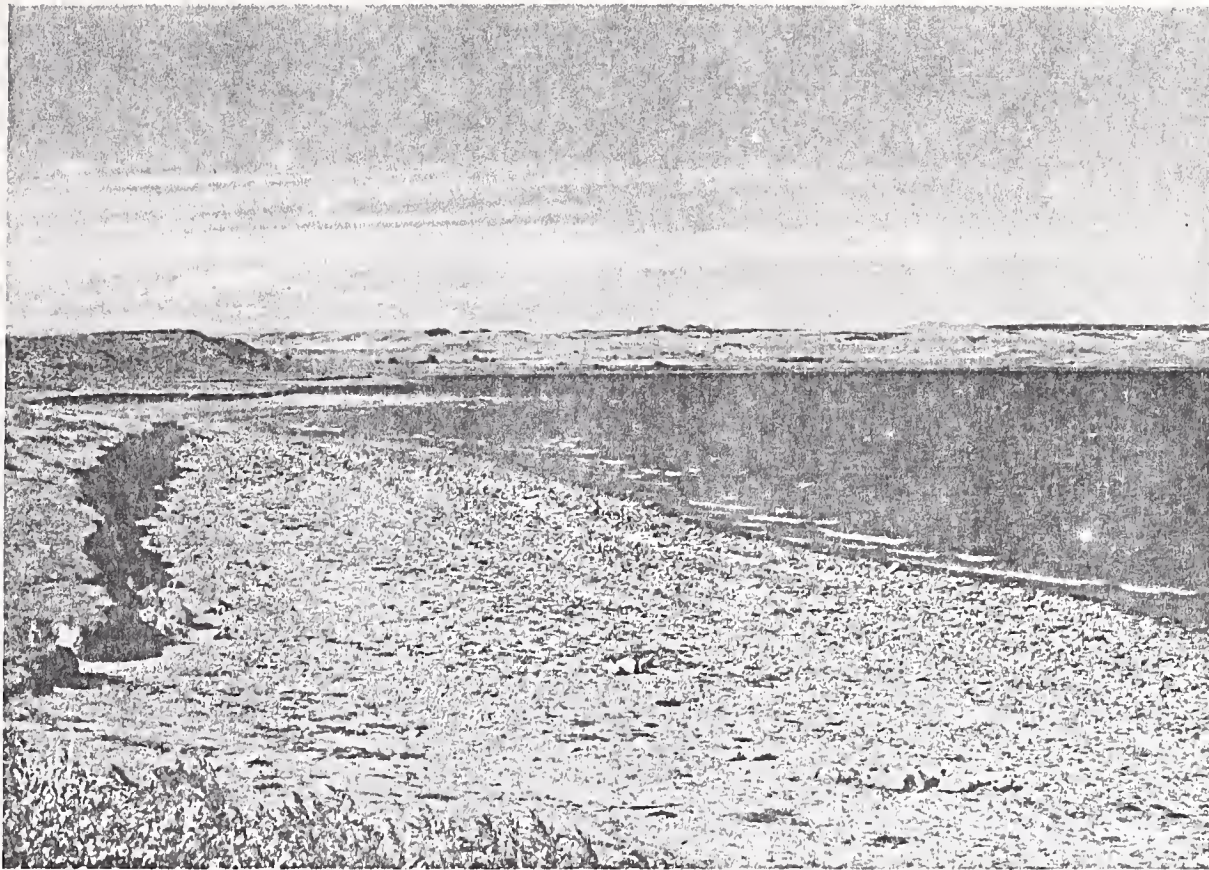
Photo No. 11 - South Shoreline  
 Local drainage basin can be seen in the background.  
 Notice the cutting action of the water at high pool.

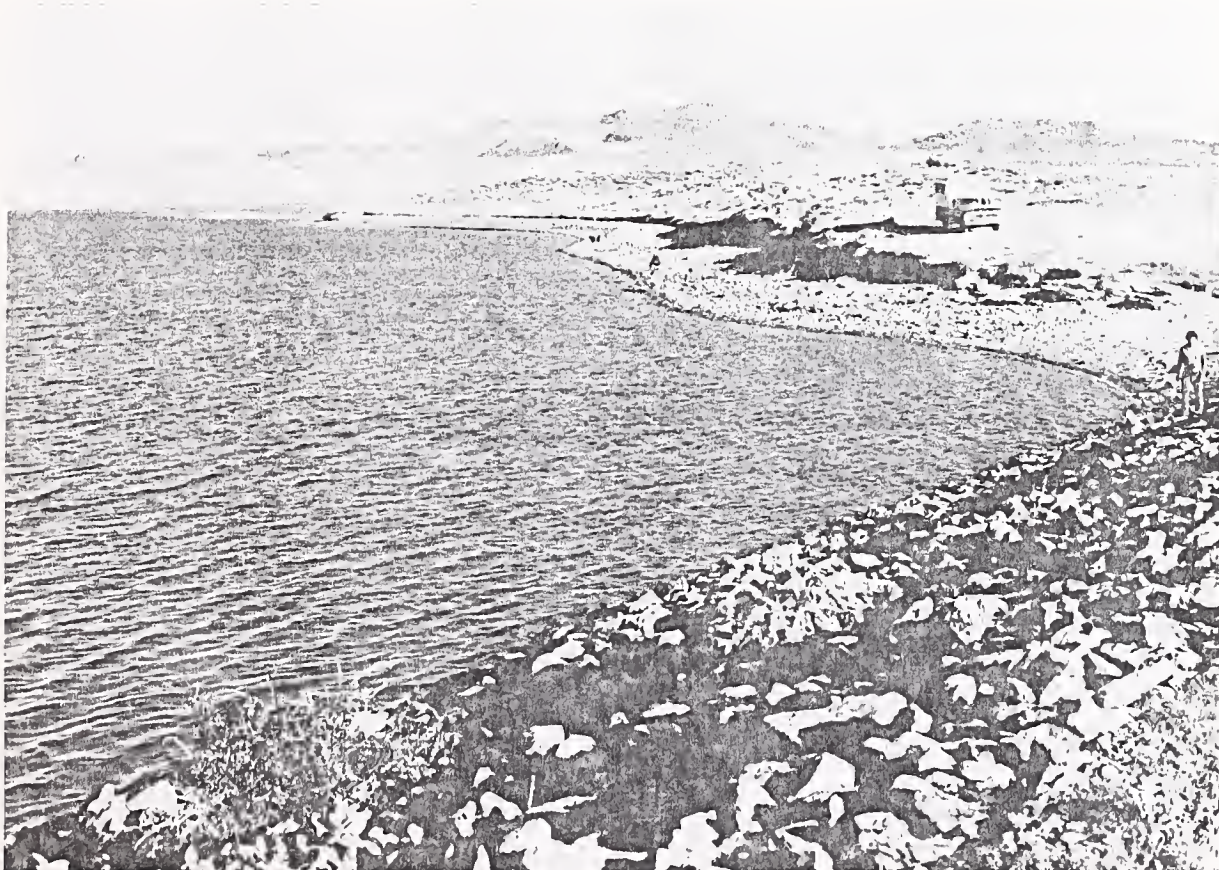
Photo No. 12 - North Shoreline  
 Notice the vegetative growth on the riprap face of the  
 embankment. Also notice areas of vertical bank cutting  
 along shoreline.

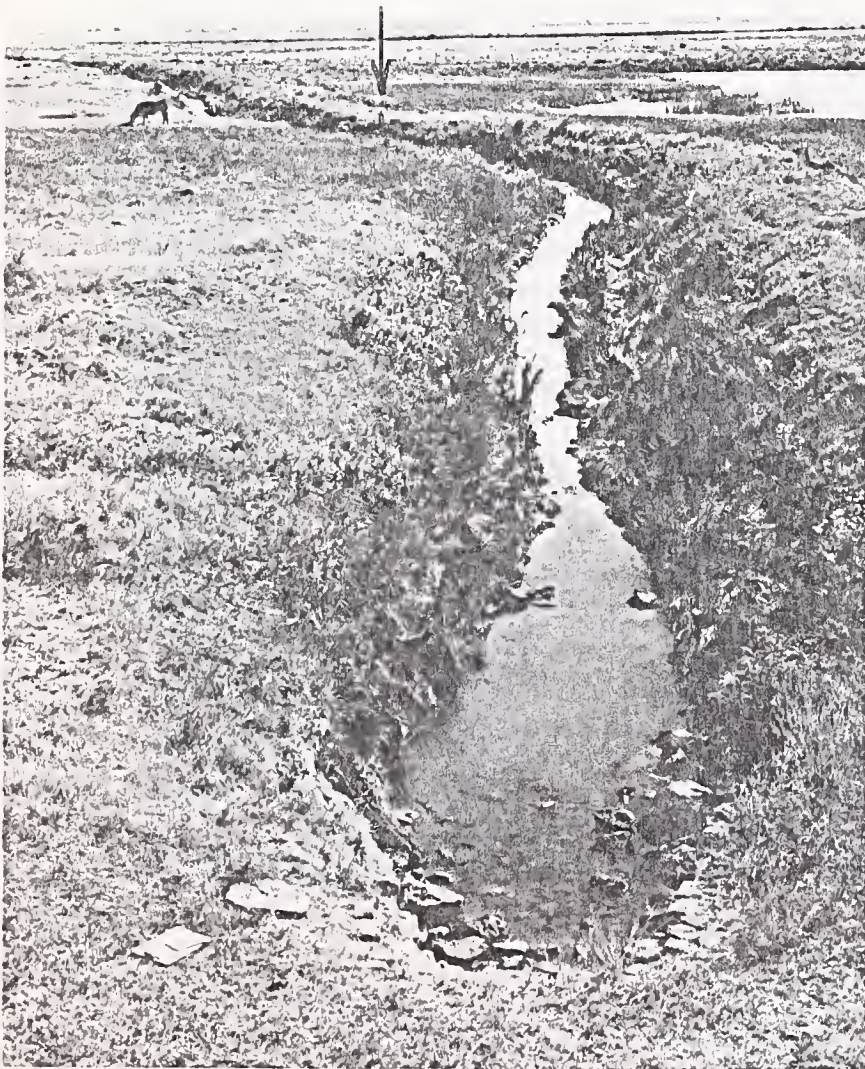
Photo No. 16 - Outlet Works  
Return Channel

The outlet structure presently consists of mortared rock sidewalls and a mortared rock headwall. The sidewalls are slightly flared in transitioning from the 42-inch diameter pipe to a small stilling basin (Photos 16 and 18 of Appendix C). The mortar has deteriorated along the sidewalls and rock has dropped into the stilling area. Bank erosion has occurred downstream of the mortared rock sidewalls (Photo 16).

A small irrigation canal conveys the reservoir releases downstream as part of the irrigation delivery system. The canal is unlined, is trapezoidal in shape, and has well vegetated banks. Other than some bank sloughing, the canal appeared to be in good condition (Photos 16 and 17).

Looking downstream from the embankment.  
Notice the diversion structure (see  
arrow) which allows water to enter the  
pond in the upper right of the photo.

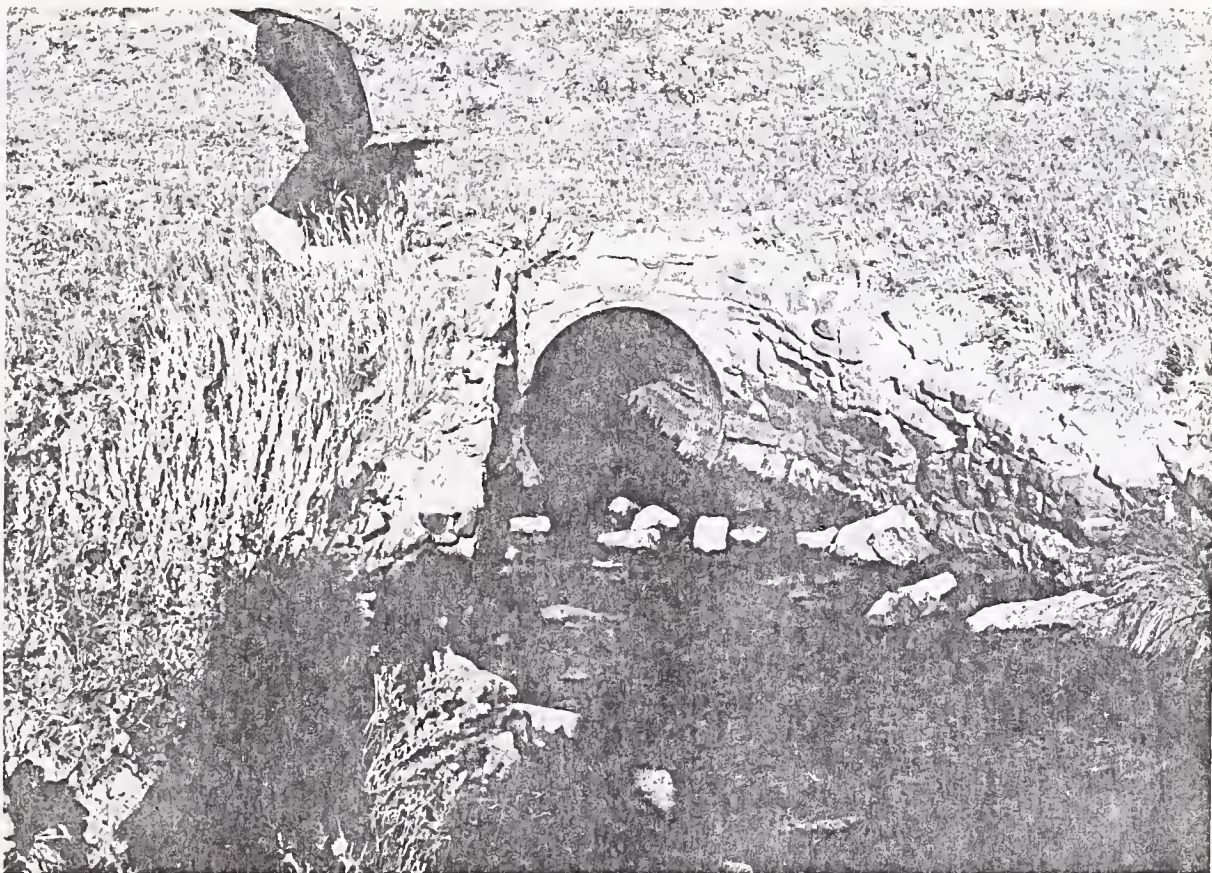
Photo No. 18 - Outlet Conduit and Structure  
The outlet channel immediately below the outlet is constructed of sandstone inlaid in mortar. Notice the riprap in the bottom of the channel. Conduit is a 42-inch corrugated metal pipe.

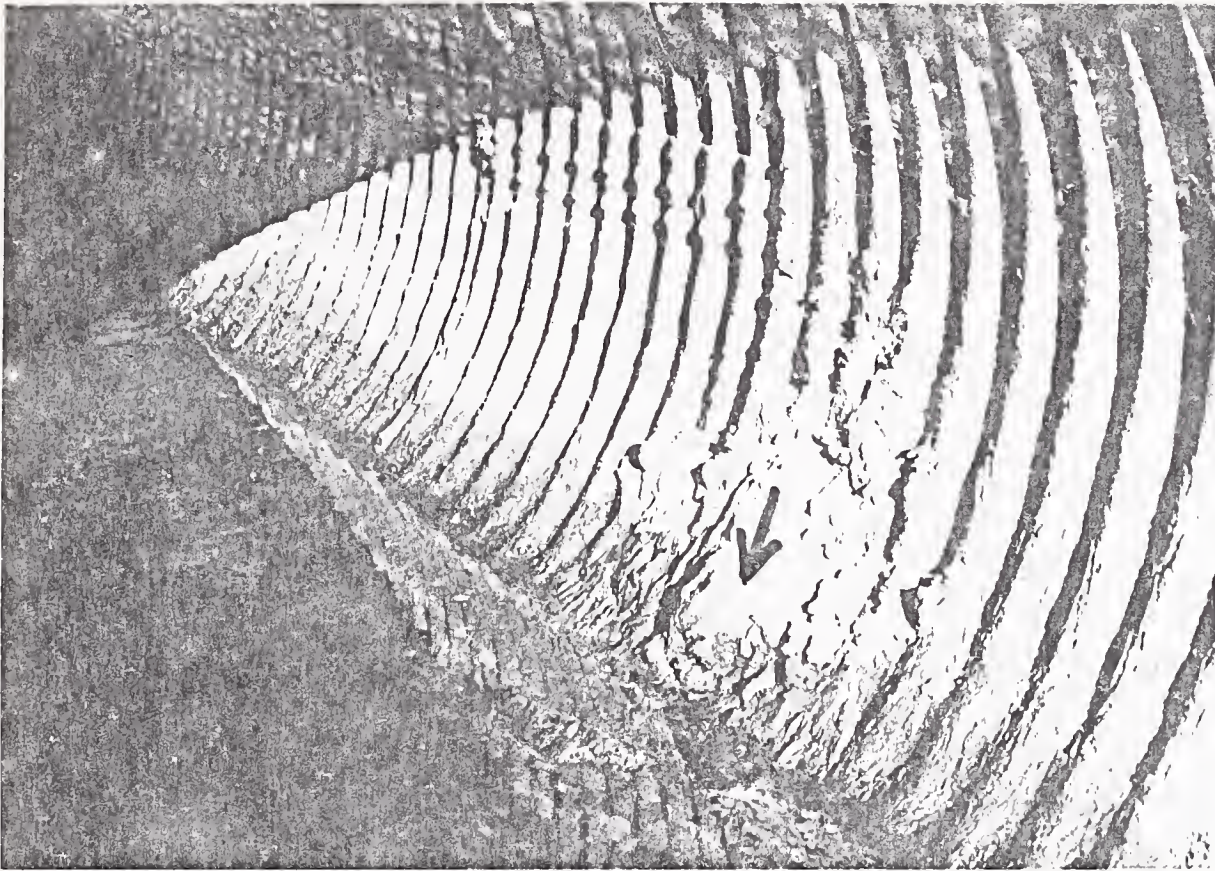
Photo No. 19 - Outlet Conduit

to the outlet. The pipe invert had been grouted or paved in the past to protect and/or cover severely eroded pipe sections. Some of this grout material is deteriorating; in fact, a large portion has been removed by erosion immediately downstream of the gate. It is possible to feel the earth and gravel foundation below the pipe where the grout section has been removed. Some interior bituminous coating was still evident along the conduit, particularly above the normal flow line. Moderate to severe erosion and corrosion of the pipe material was evident throughout the pipe interior. There are many rocks, as large as 12-inches in diameter, located along the pipe invert. The horizontal alignment of the conduit is good.

At the 85-foot distance upstream of the outlet, the mastic joint covering is badly deteriorated. At this same point, there is a depression in the pipe crown. There is a significant inward bulge in the pipe sidewall approximately 80-feet upstream of the outlet. Grout has been injected in the pipe sidewall 18 inches from the outlet (Photo 19 of Appendix C).

This photo shows a location where a hole has been made in the pipe, then grout was pumped in behind the pipe (see arrow). Notice the corrugated metal pipe is badly deteriorated. The bituminous coating is almost completely weathered and eroded off of the conduit.

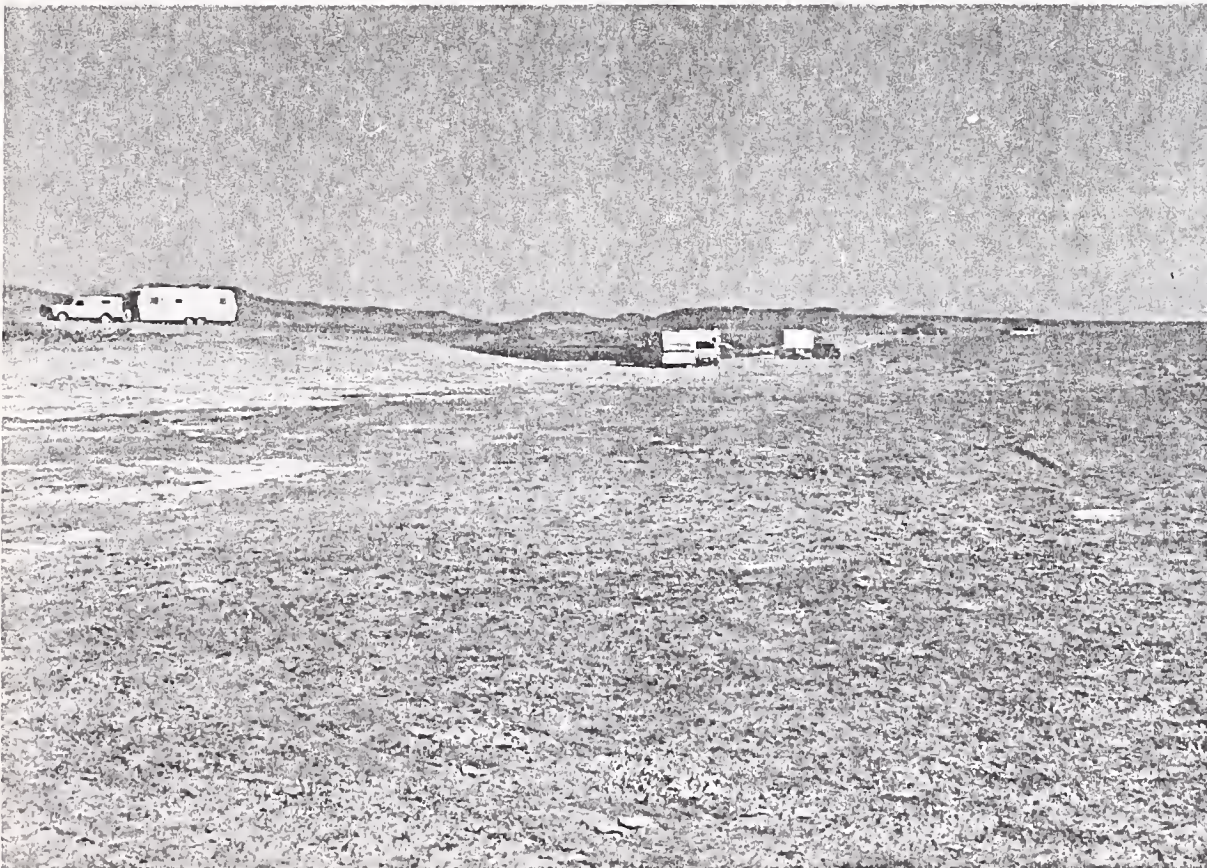
Photo No. 20 - Spillway

The spillway was noted as being generally in excellent physical condition at the time of the September 1979 inspection, primarily because it had not operated to that date (Photos 20-23). It is anticipated, however, that some channel bank erosion will be experienced in the future unless some means of stabilization is provided. This potential problem is particularly true for the left spillway bank, and during high flows when the average flow velocities in the channel will approach 10 feet per second. Erosion potential along the right spillway bank, which is the dike section containing the reservoir pool, is not as great. Hence, localized bank erosion should not create a safety hazard to the reservoir containment structures. It is also anticipated that localized scour holes are likely to develop along the spillway floor with some local disconfiguration. Extensive or deep cutting along the flowline is not expected because of the sandy shale barrier. The field inspection and survey revealed that the spillway channel was constructed with an unfavorable bed slope; in fact, it is quite irregular and even an "adverse" slope in some reaches (Sheet 4 of Exhibit D1).

This photo was taken from the center of the spillway looking north toward the reservoir.

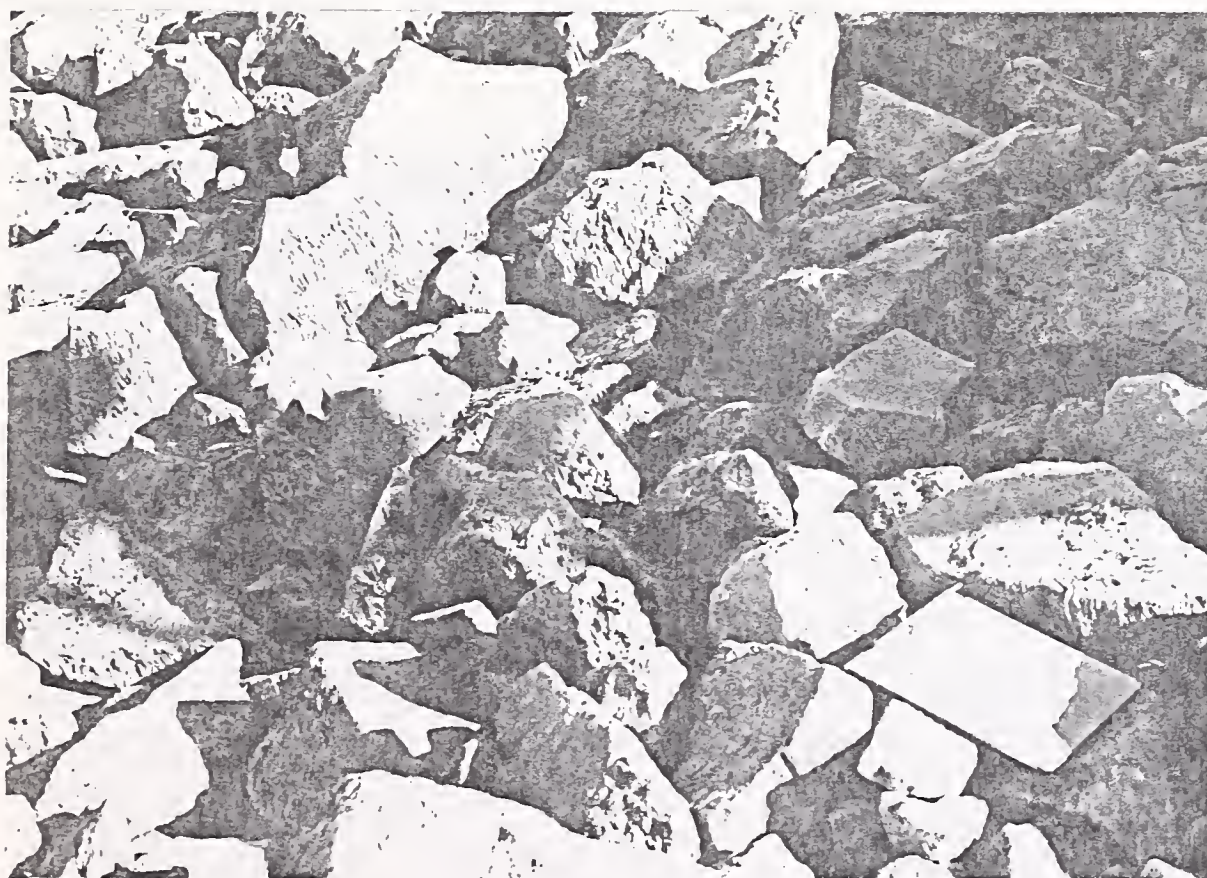
Photo No. 24 - Rock Riprap

The riprap is located on the upstream face of the dam.  
It is sandstone with a mean size of about 12 to 14 inches.  
This material is in good condition.

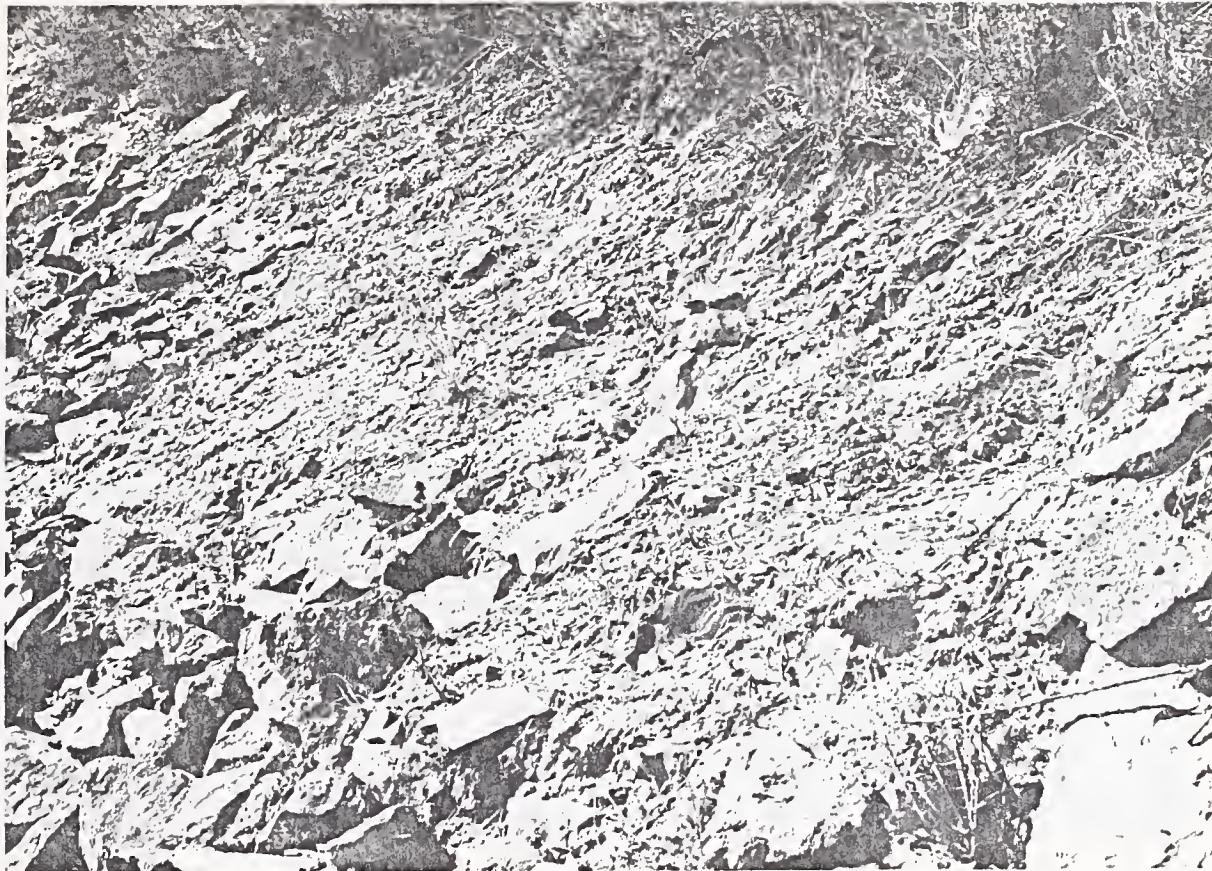
Photo No. 25 - Rock Riprap

The embankments of the Yellow Water dams appear to be stable except for the oversteepened areas on the upstream face of the main dam where the rock riprap has moved downslope. Several seepage areas were identified during the field investigation; however, no seepage-related problems were apparent except for the outlet works conduit. The conduit has experienced serious corrosion and erosion to the extent that the foundation and embankment materials are exposed in isolated locations, thus creating an exfiltration path into the embankment. Past grouting and patchwork has proved to be only a temporary corrective measure.

In some places the riprap protection has slid down the face leaving the embankment exposed.

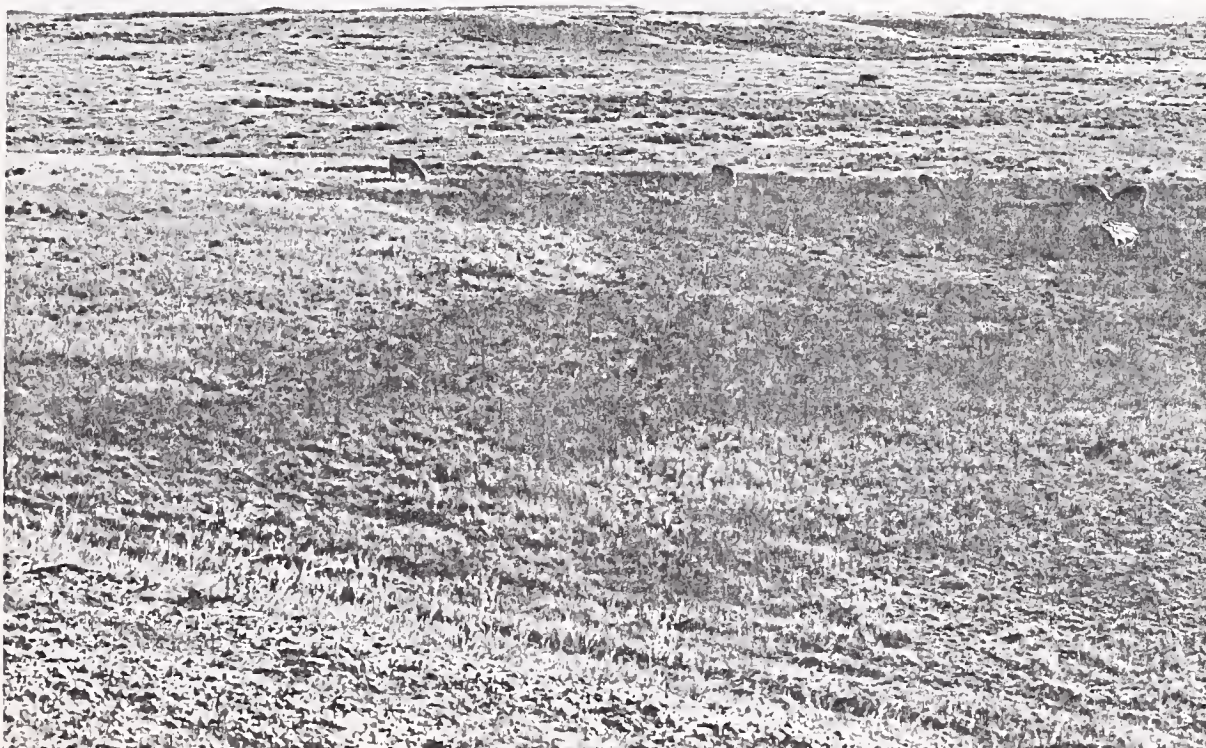
Photo No. 26 - Seepage on the Left Abutment

On the left abutment the groundwater appears high. This green patch of grass suggests seepage through the abutment is keeping the area wet.

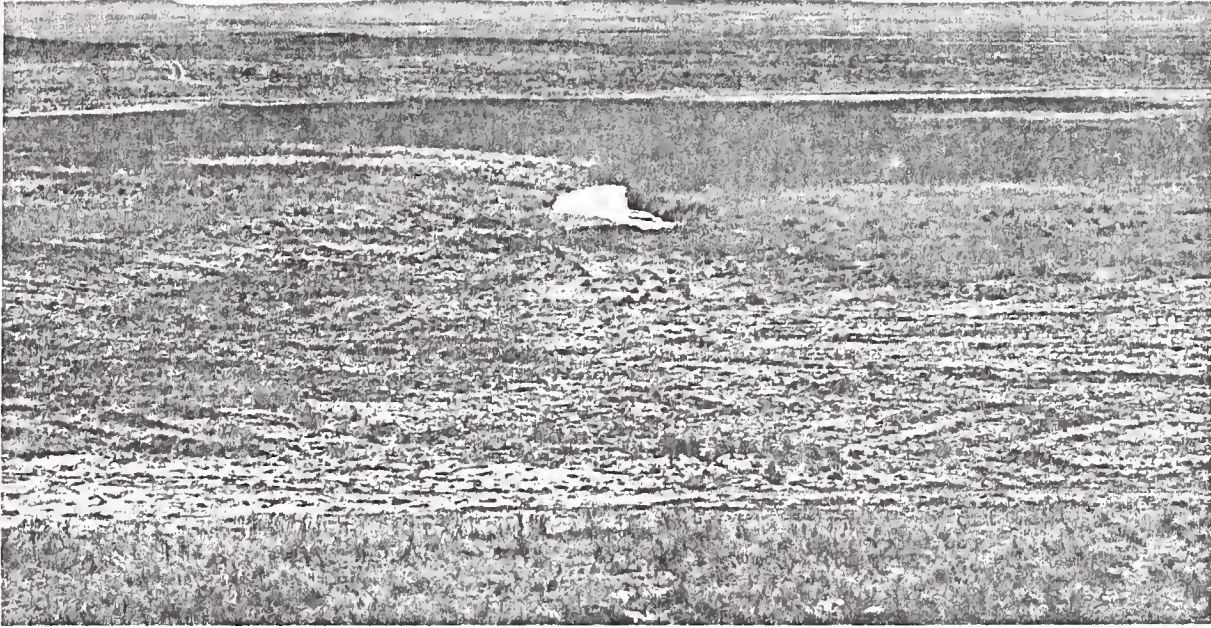
Photo No. 27 - Springs Downstream

Numerous springs are evident downstream. The seepage appears to be running along the surface of the bedrock shale and exiting where the bedrock is exposed.

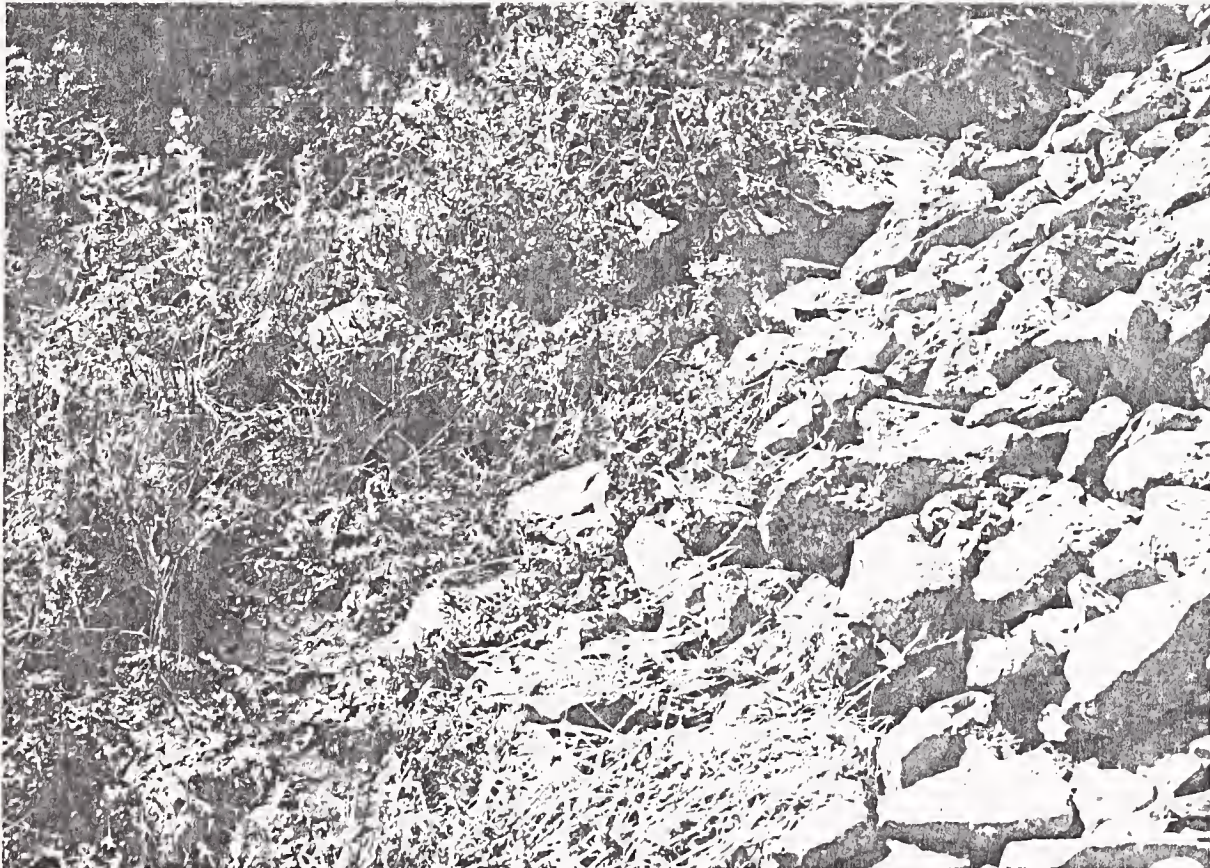
Photo No. 28 - Seepage

Numerous springs are exiting at the downstream rock toe. The toe drain is designed to carry seepage. These springs do not pose a stability problem.
